Exmoor National Park
Historic Environment Report Series No 20

DULVERTON CONSERVATION AREA: APPRAISAL DOCUMENT

Consultation Draft: November 2014

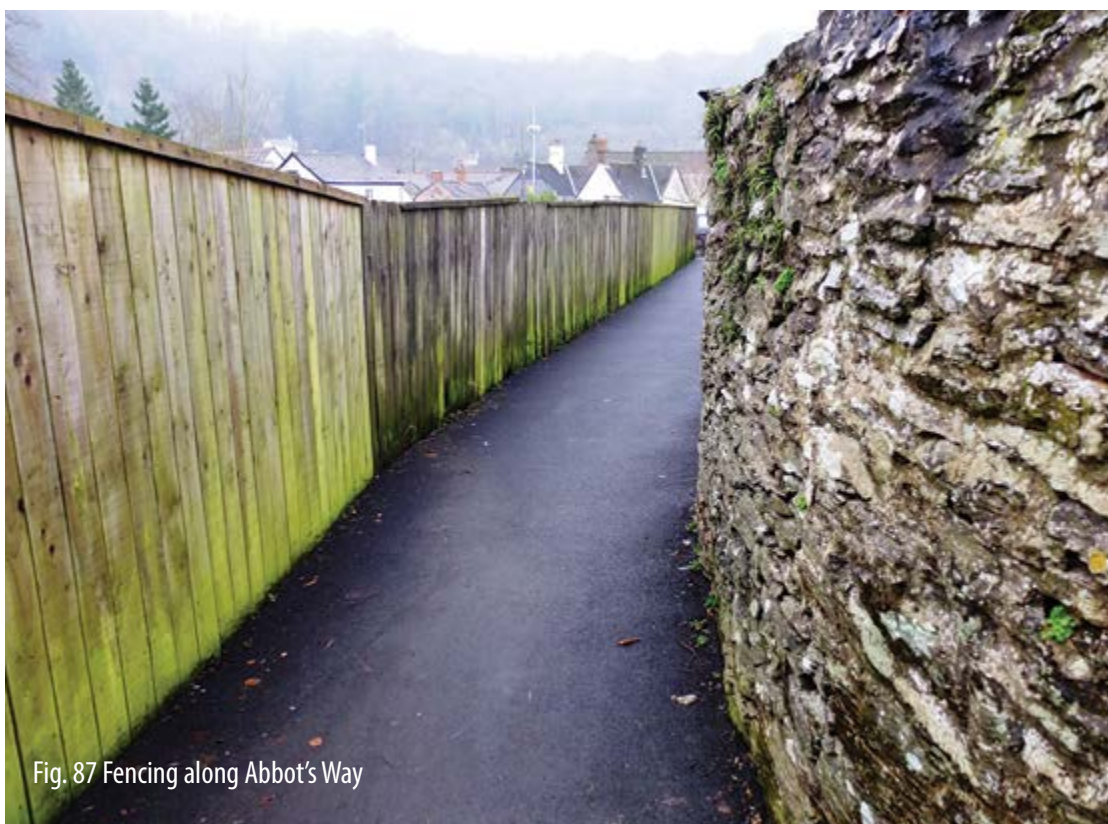
Fig. 87 Fencing along Abbot's Way

Overhead lines are prominent throughout parts of the town centre, and especially several of its approaches. There are also areas where boundary treatments are not ideal, notably the post-and-panel fencing alongside the Abbot's Way footpath (Fig. 87).

The gap in the buildings along the High Street at the junction with Union Street at the entrance to the Lion Stable public car park would benefit from some enhancement. From here, the fencing along the Abbot's Way footpath is not inkeeping with Dulverton's historic character.

- The conservation, and where necessary, the repair of walls and/or historic railings, and timber fencing is considered important. Where appropriate consider using additional timber or ironwork that reflects the local craft traditions.

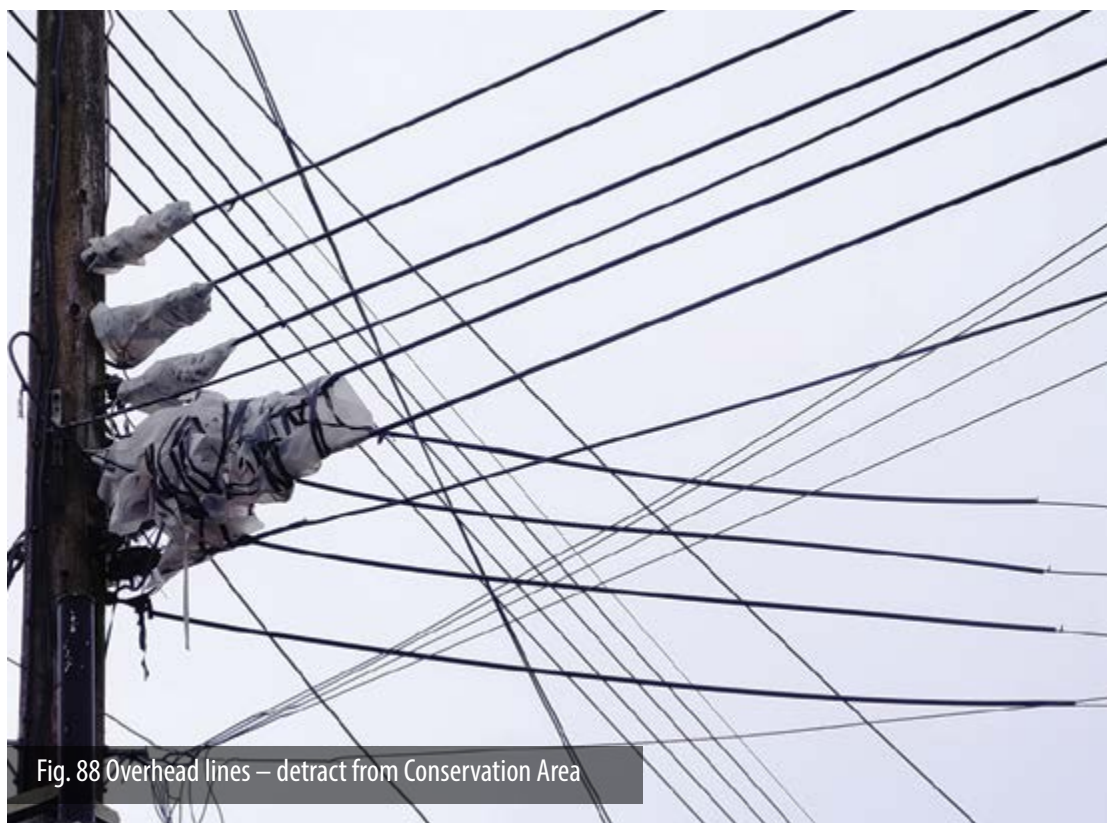
Fig. 88 Overhead lines – detract from Conservation Area

- removal of unsightly overhead power lines, from parts of the town centre where this has not already been done.
- where feasible, the restoration of some historic water features.
- a survey of all ground surfaces where natural materials have been used (cobble, paving and kerbs with recommendations for repair and additional surfacing).
- better interpretation of the town including a possible town trail.
